Degradation of Continuous Fiber Ceramic Matrix Composites Under Constant-Load Conditions

Michael C. Halbig and David N. Brewer U.S. Army Research Laboratory, Glenn Research Center, Cleveland, Ohio

Prepared for the
Symposium on Environmental, Mechanical, and Thermal Properties and Performance
of Continuous Fiber Ceramic Composite (CFCC) Materials and Components
sponsored by the ASTM Committee C–28 on Advanced Ceramics
Seattle, Washington, May 18, 1999

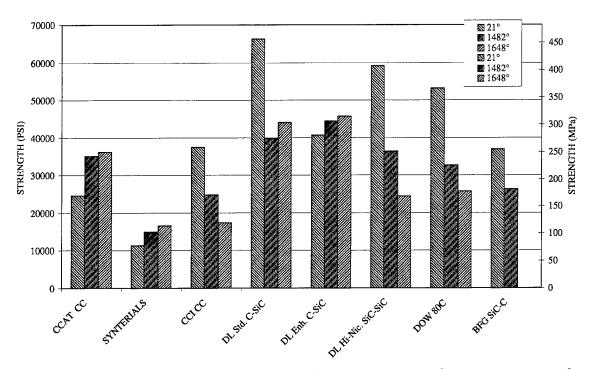
Figure 1—The tensile strength of eight of the program materials at temperatures of 21, 1482 and 1648°C (70, 2700 and 3000°F). Tensile testing conducted by SRI.

In order to interpret better the results of stressed oxidation testing, the ultimate tensile strength of the materials should be known. The results of tensile tests conducted by SRI at 21, 1482, and 1648°C (70, 2700 and 3000°F) are shown in Figure 1. As illustrated by the strengths at elevated temperatures, the C/SiC composites typically have higher strengths than the SiC/SiC composites. The specific C/C materials supplied by the venders show some variation in strength.

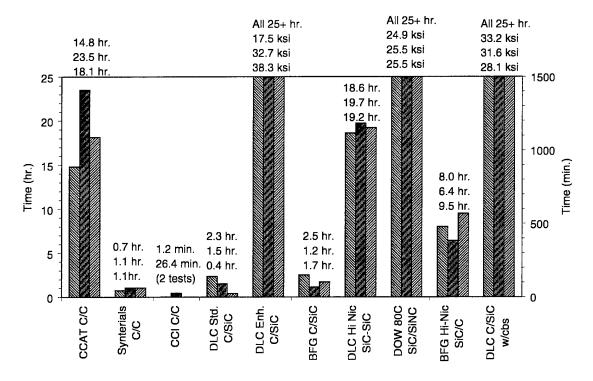
Figure 2—Times to failure for stressed oxidation tests at 1454°C/69 MPa.

The times to failure for the samples stressed oxidation tested at 69 MPa are shown in Figure 2. Three of the materials survived 25 hours of exposure. The three materials (DLC enhanced C/SiC, DLC C/SiC w/cbs, and Dow SiC/SiNC) all had oxidation protection enhancements which, seem to be a key in prolonging the life of both C/SiC and SiC/SiC composites. The DLC enhanced C/SiC material has a boron containing particulate in the composite that acts as an oxygen getter and forms borosilicate glasses that seal cracks and protect the fibers from oxidation. The DLC C/SiC material with a cbs (carbon, boron, and silicon) coating uses a similar method of oxidation protection as the enhanced C/SiC material, however, a boron containing coating also provides an exterior form of protection. The Dow SiC/SiNC uses a proprietary, non-carbon, interphase on the SiC fibers. The three materials had relatively high residual strengths as determined from room temperature tensile tests. Two other materials, CCAT C/C and DLC SiC/SiC, did fail within 25 hr, but had relatively longer lives compared to the five other materials that failed at shorter times.

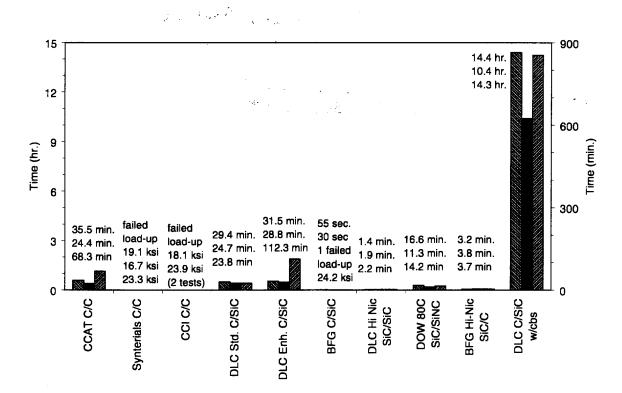
Figure 3—Times to failure for stressed oxidation tests at 1454°C/172 MPa.

The times to failure for testing at a stress of 172 MPa are shown in Figure 3. All of the materials either failed on load-up or had much shorter lives than at 69 MPa with the exception of the DLC C/SiC material with the cbs coating. This material had lives over ten hours while the other materials either failed load-up or had lives of a few minutes or about half an hour. The cbs coating enhancement in the DLC material seems to be effective in sealing cracks and protecting the fibers even at stresses as high as 172 MPa. It should be noted that the DLC enhanced C/SiC and the DLC C/SiC w/cbs materials had failures in a thermal gradient region located in between the heated gage section and the water-cooled grips. This suggests that the enhancements in these materials are effective at our specific temperature of 1454°C, however the materials may be susceptible to degradation at intermediate temperatures.

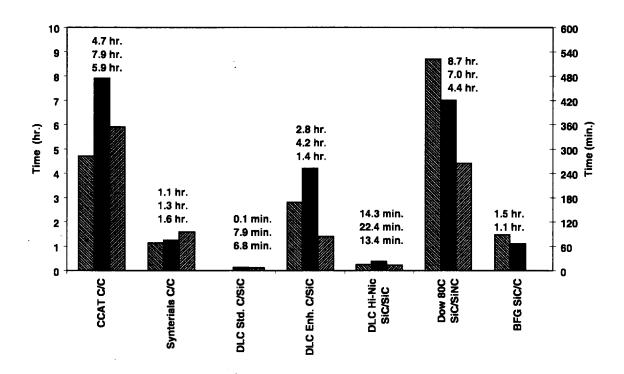
Figure 4—Times to failure for stressed oxidation tests at 1454°C/50% UTS.

Stressed oxidation was also conducted at stresses of 50% of the ultimate tensile strength of each material. The times to failure are shown in Figure 4. Testing at this stress was conducted so that all materials could be evaluated at a stress that seemed to be fairer for all materials regardless of the maturity of the material or the material type. However 50% of the UTS is likely above the first matrix cracking stress for the SiC/SiC and SiC/SiNC materials. Of the seven materials tested at this stress, two materials did better than the rest (CCAT C/C and Dow SiC/SiNC).

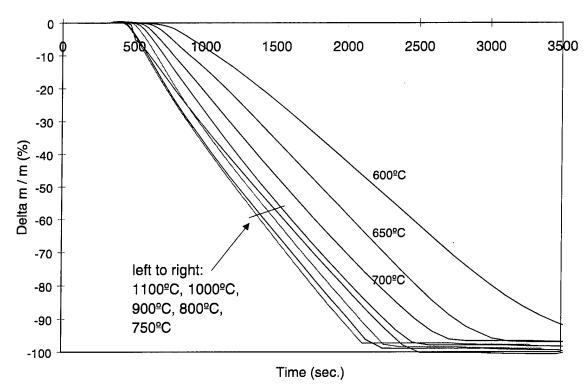
Figure 5—Weight loss versus time of T300 carbon fiber in flowing oxygen at temperatures ranging from 600–1100°C.

Before the effect of a constant load on C/SiC composites is evaluated, it is beneficial to have an understanding of how the material and its fiber constituent behave in unstressed, high temperature, oxidizing conditions. The percent weigh loss of T300 carbon fiber versus time at temperatures ranging from 600-1100°C is shown in Figure 5. Slower reaction rates are seen for temperatures ranging from 600-750°C. Faster reaction rates and less of a temperature dependence are observed at temperatures above 800°C. At all temperatures, the approximately 0.4 grams of carbon fiber had completely oxidized away within an hour. These same trends were observed in thermogravimetric analysis (TGA) experiments on T300 fiber conducted by Lamouroux et al [6].

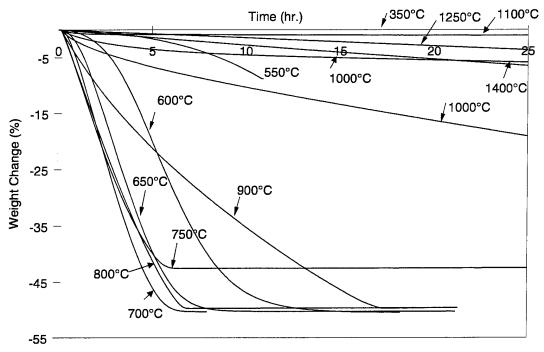
Figure 6—Weight loss versus time of standard C/SiC in flowing oxygen at temperatures ranging from 550–1400°C.

The oxidation of the fully exposed T300 fiber is contrasted by the TGA results of externally-seal coated C/SiC test coupons as shown in Figure 6. At low temperatures, oxygen is able to diffuse into the pre-existing cracks within the composite and react with the carbon fibers. At 550°C, the start of a downward trend in weight loss is observed however the test had to be stopped early. At 750°C, oxidation occurs sooner and at a faster rate. Complete fiber burnout was observed to occur within 5 hours. However, at the higher temperatures, the trends in weight loss and complete fiber burnout did not continue as observed in the TGA tests conducted on the bare T300 fiber. As test temperatures were increased, weight loss rates greatly decreased so that low weight losses were observed even after 25 hours. It should be noted that two tests were conducted at 1000°C and both had different oxidation rates, which are believed to be due to the difference in pre-existing cracks in the external seal coating. Microstructural analysis of polished cross-sections revealed that one sample oxidized uniformly from the outer edges toward the interior while in the other sample significant oxidation occurred from one edge toward the interior but at the opposite edge little oxidation occurred.

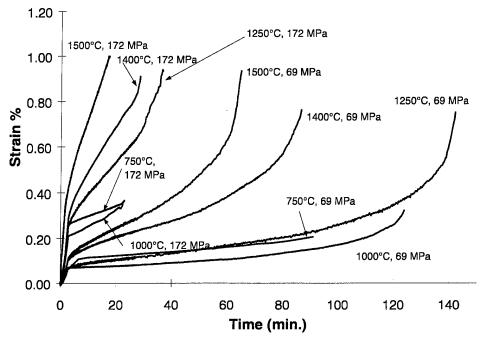
Figure 7—Strain versus time curves from stressed oxidation testing of C/SiC at stresses of 69 MPa (10 ksi) and 172 MPa (25 ksi) and temperatures from 750–1500°C.

When a constant load is applied to C/SiC at elevated oxidizing temperatures, the applied stress opens existing cracks and allows for easier ingress of oxygen to the fibers. At sufficiently high stresses, cracks may be open too wide for crack closure and sealing to occur. The results of stressed oxidation of DLC's standard C/SiC material at stresses of 69 MPa and 172 MPa and at temperatures ranging from 750°C-1500°C are shown in Figure 7 [11]. This batch of material is two years older than the DLC standard C/SiC material tested under the NASA MSFC CMC Material Robustness Program.

In the strain versus time curves, the effect of stress can be seen. As expected, the samples tested at the higher stress had shorter lives. The samples tested at 172 MPa had curves that fall to the left side of the plot while the samples tested at 69 MPa had longer lives and were concentrated to the right side of the plot. Although the times to failure across the temperature range occurred within a fairly narrow range, times to failure increased from 750°C to 1250°C and then decreased at temperatures higher than 1250°C for both stresses. Another effect from temperature is the strain to failure. Samples tested in the higher temperature range showed a much more pronounced tertiary regime and higher strains to failure.

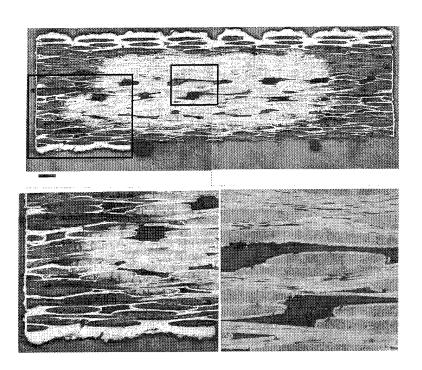
Figure 8—Diffusion controlled kinetics. Optical micrograph of a polished cross-section of a C/SiC sample stressed oxidation tested at 1400°C/69 MPa. Time to failure was 86 minutes.

Scale bar in top micrograph equals 0.5 mm.

The model was run at values (i.e. reaction rate constant, diffusion coefficient, and total oxygen concentration at the edge) correlating to conditions at 1400°C in air, and was compared to the microstructure of a tested coupon. Figure 8 shows the polished cross-section of a sample that had been stressed oxidation tested at 1400°C/69MPa. Severe carbon consumption is seen around the perimeter of the sample (darkened regions in the micrograph). In the close-up views, a reaction front can be seen as carbon is immediately oxidized as soon as oxygen is supplied so that the interior is starved in oxygen and no oxygen is present to react with carbon in the interior of the matrix. In the close-up view of the interior, a large void and cracks in the fiber tows are seen, however, no evidence of oxidation is observed. The oxidation patterns shown in Figure 8 suggest a steep gradient in oxygen concentration at the reaction front toward the interior of the sample. This is an oxidation pattern that would be expected from diffusion controlled kinetics. The results from running the model at conditions for 1400°C are shown in Figure 9. The oxidation pattern on a 2-dimensional surface within the fiber bridged region is shown at various stages in the top row of plots. A shrinking core effect is seen as fibers on the outer perimeter are consumed first and then the reaction front moves inward to the next perimeter of fibers. The interior fiber tows remain unreacted until the oxygen supply reaches them. The correlating oxygen concentration plots for one-quarter of the 2-dimensional section are shown in the bottom row. A steep gradient in oxygen concentration can be seen at the edge of the reaction front toward the interior of the sample. The interior is shown to be deprived of oxygen. These patterns agree well with experimental observations and suggest diffusion controlled kinetics at this relatively high temperature.

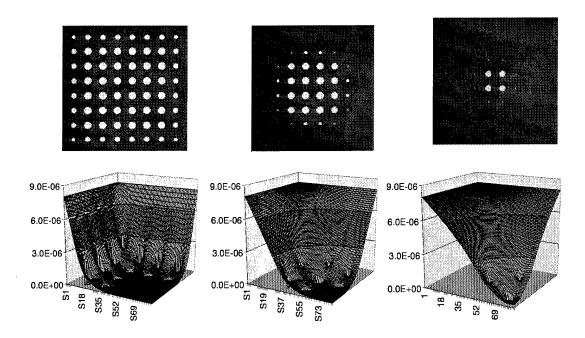
Figure 9—Diffusion controlled kinetics for Sh=1.07 (relating to $1400\,^{\circ}$ C) at 25%, 75%, and 95% carbon consumption of the 8 x 8 fiber array. The top illustrations are of the remaining area of carbon on the 2-dimensional surface. The bottom plots are of the related oxygen concentrations (mol//cm3) for one quarter of the surface.

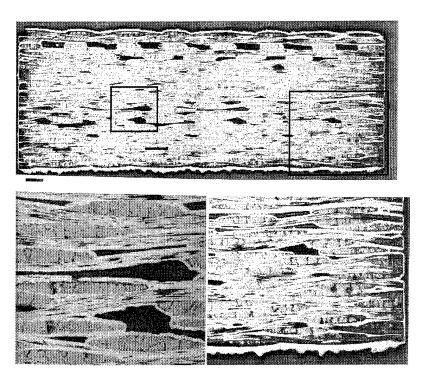
Figure 10—Reaction controlled kinetics. Optical micrograph of a polished cross-section of a C/SiC sample stressed oxidation tested at 700°C/69 MPa. Time to failure was 91 minutes. Scale bar in top micrograph equals 0.5 mm.

The model was also run at values correlating to conditions at 700°C, and were compared to the polished cross-section of a test coupon that had been stressed oxidation tested at 750°C. Figure 10 shows the polished cross-section of a sample stressed oxidation tested at 750°C/69 MPa. Minimal and uniform oxidation is seen along the edge of the sample as well as deep in the interior of the sample along the edges of fiber tows (bundles) and along the matrix cracks within the tows. This pattern suggests that the carbon/oxygen reactions are so slow that oxygen is able to bypass the carbon at the outer edge and saturate the interior at high concentrations so that oxygen is available throughout the matrix to supply the slow reaction process. This is the oxidation pattern that would be expected for reaction controlled kinetics. The results from running the model at conditions for 700°C are shown in Figure 11. The oxidation pattern of the bridging fiber tow array on the 2-dimensional surface is shown in various stages in the top row of plots. The correlating oxygen concentration plots for one-quarter of the section are shown in the bottom row. Uniform carbon reactions and high oxygen concentration are seen throughout the 2-dimensional surface of the matrix. These patterns agree well with experimental observations and suggest reaction controlled kinetics at this relatively low temperature.

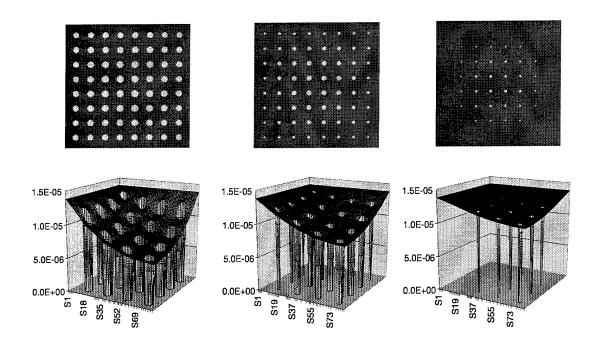
Figure 11—Reaction controlled kinetics for Sh=1.57E-2 (relating to 700°C) at 25%, 75%, and 95% carbon consumption of the 6 x 6 fiber array. The top illustrations are of the remaining area of carbon on the 2-dimensional surface.

The bottom plots are of the related oxygen concentrations (mol/cm³) for one quarter of the surface.
